MEMORANDUM

DATE:	October 31 st , 2016
FROM:	Eric Lancaster
SUBJECT:	Weekly Progress Report @ Gold King
TO:	Kerry Guy

Project: Gold King Interim Water Treatment Plant (IWTP)

Report No.: 42

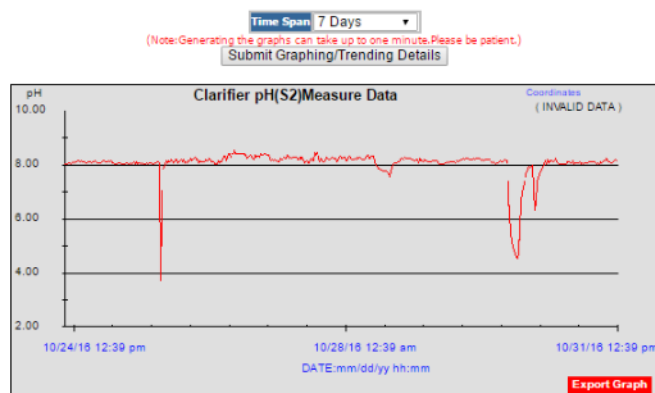
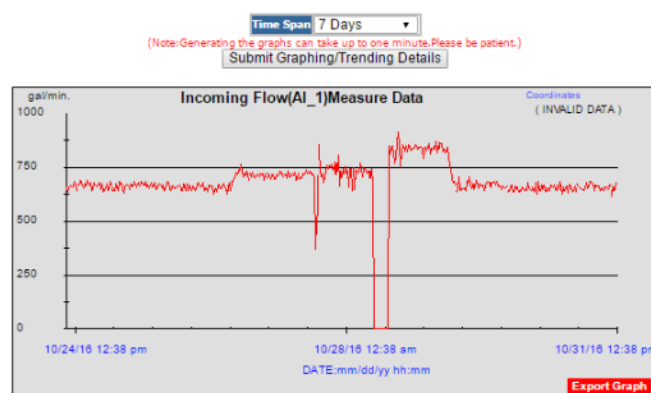
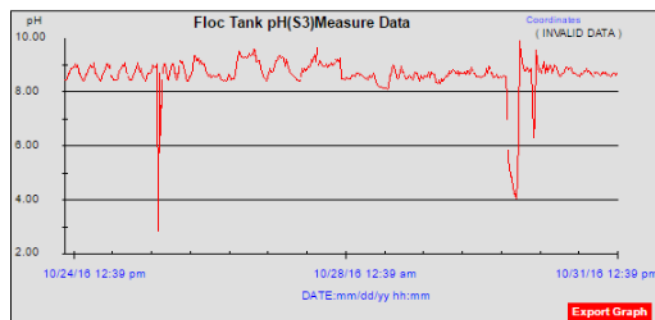
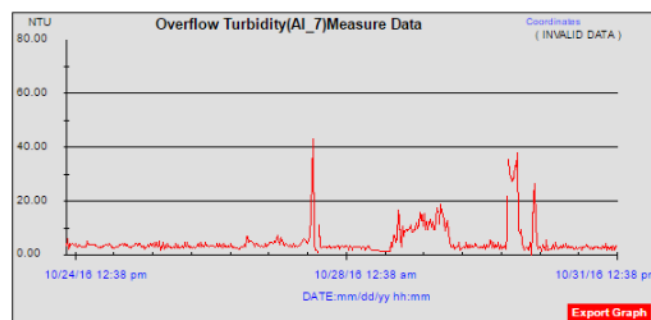
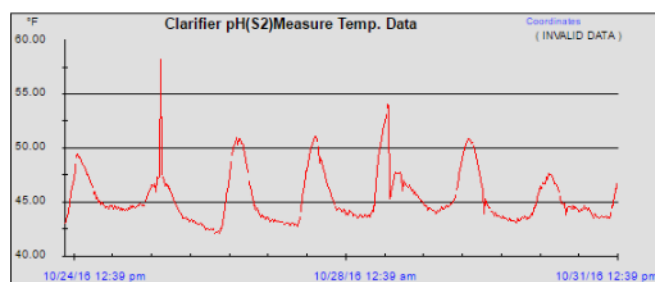
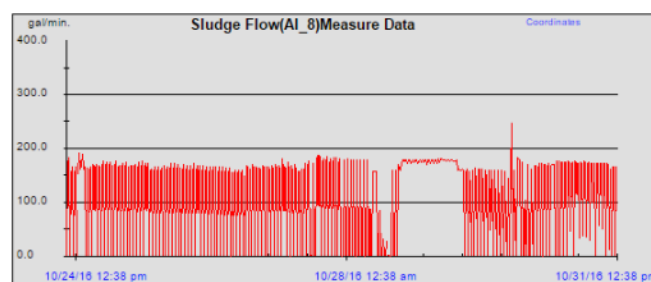
- The following graphs provide trending information during the previous 7 days. The dataloggers collect control information from the Lime Circuit (left) and Flow Circuit (right) Programmable Logic Controllers (PLCs) at the Gold King IWTP. Over the reporting period (10/24 – 10/31/2016 inclusive) Alexco treated 7.04 million gallons at an average flow rate of 698 gpm.
